Subject: Department of Natural Resources Washington Geological Survey,
School Seismic Safety Assessment Project, Contract No. AE 410 -
Seismic Evaluation for **Dixie School District**

School Buildings Evaluated in the Dixie School District

1. Dixie Elementary School, Main Building

Dixie, Dixie Elementary School, Main Building

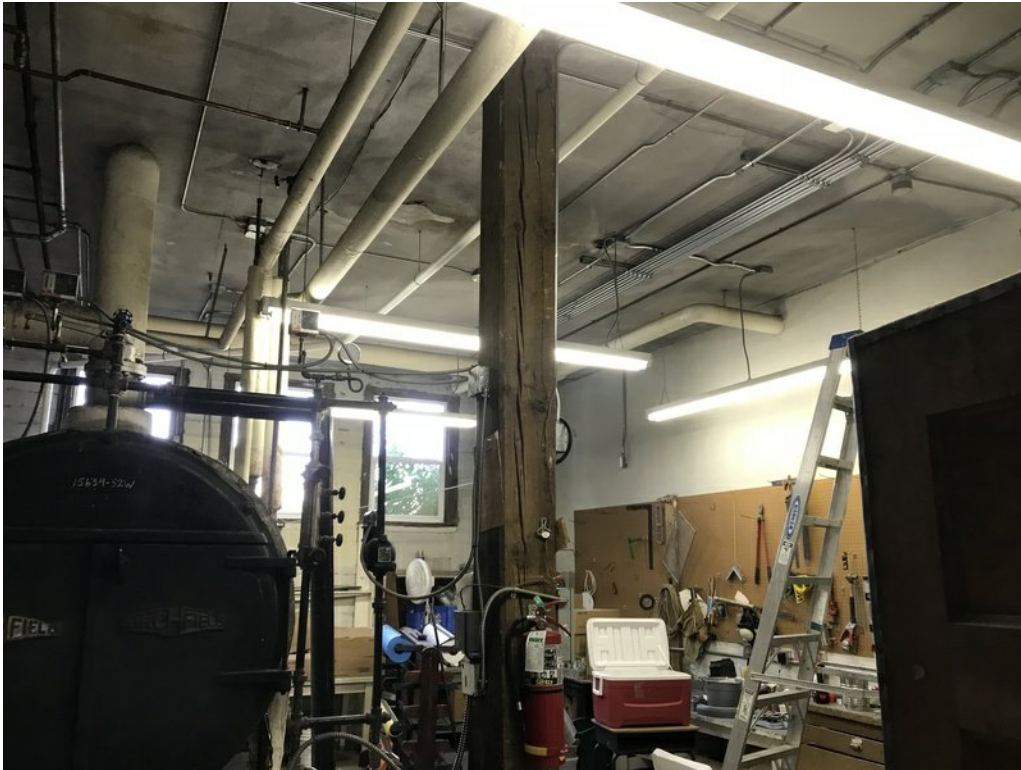
Figure 1-1. Large wood post in basement mechanical room.

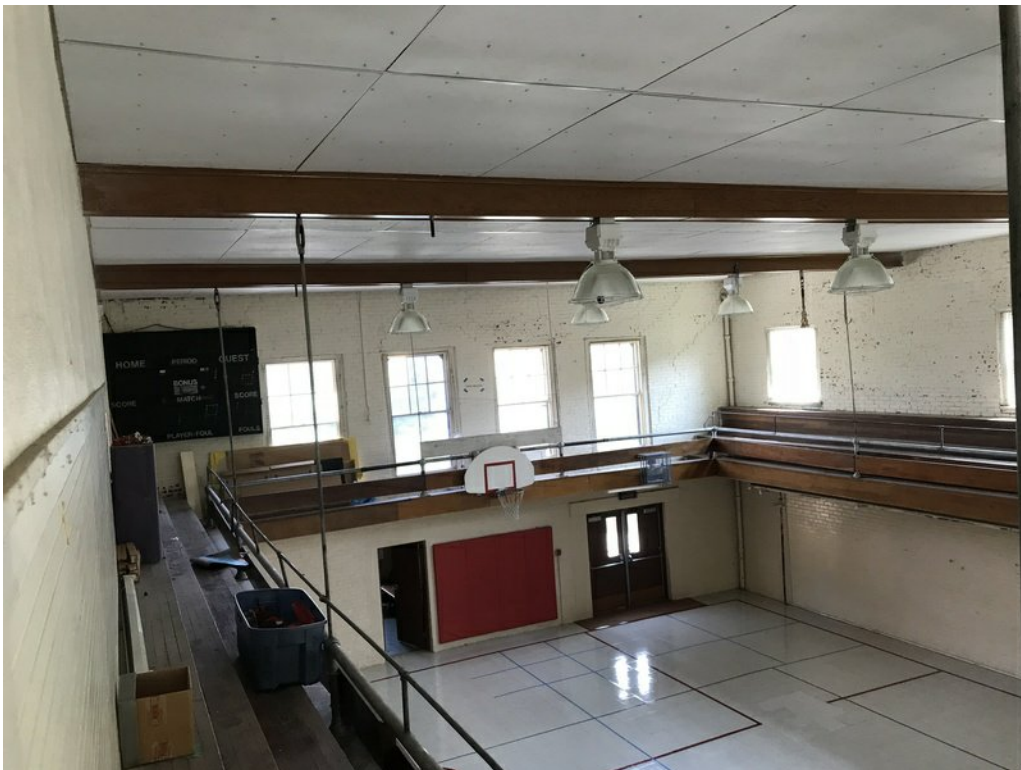
Figure 1-6. View of gymnasium's east wall from mezzanine. It was noted the mezzanine was structurally questionable during visit. Cracks can be seen near far corner of gym.

EVALUATION ITEM	EVALUATION STATEMENT	C	NC	N/A	U	COMMENT
Load Path	The structure contains a complete, well-defined load path, including structural elements and connections, that serves to transfer the inertial forces associated with the mass of all elements of the building to the foundation. (Tier 2: Sec. 5.4.1.1; Commentary: Sec. A.2.1.10)				X	No existing drawings and inadequate access to verify; likely noncompliant based on the age of the building.
Adjacent Buildings	The clear distance between the building being evaluated and any adjacent building is greater than 0.25% of the height of the shorter building in low seismicity, 0.5% in moderate seismicity, and 1.5% in high seismicity. (Tier 2: Sec. 5.4.1.2; Commentary: Sec. A.2.1.2)	X				No adjacent structures.
Mezzanines	Interior mezzanine levels are braced independently from the main structure or are anchored to the seismic-force-resisting elements of the main structure. (Tier 2: Sec. 5.4.1.3; Commentary: Sec. A.2.1.3)				X	Connection of small mezzanine in gym is unknown but likely noncompliant.

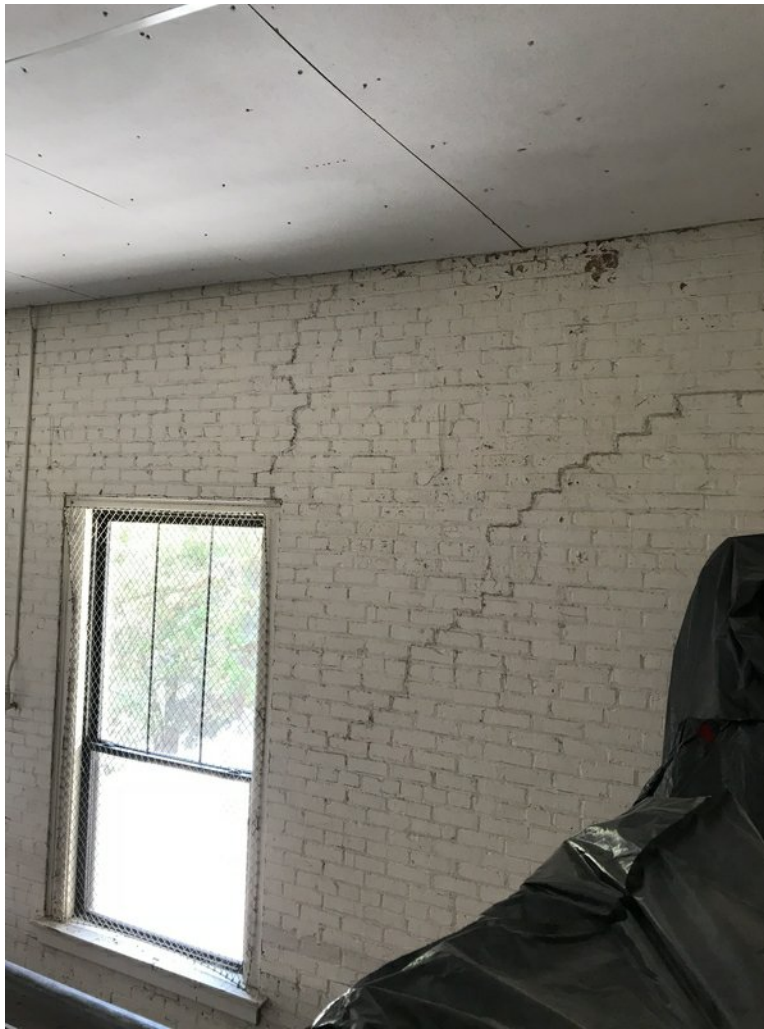
Structural System	Description
Structural Roof	Fair. No signs of corrosion, damage or deterioration; access was limited.
Structural Floor(s)	Good. No signs of corrosion, damage or deterioration.
Foundations	Unknown. Minor signs of deterioration at southwest corner of building.
Gravity System	Fair. Substantial cracking visible on gymnasium walls; cracks have translated to both in- and outside faces of the wall. Assessment of cracking by a licensed structural engineer is recommended.
Lateral System	Fair. Substantial cracking visible on gym walls. Assessment of cracking by a licensed structural engineer is recommended.

Figure 1-7. Cracks in the west wall of the gym.

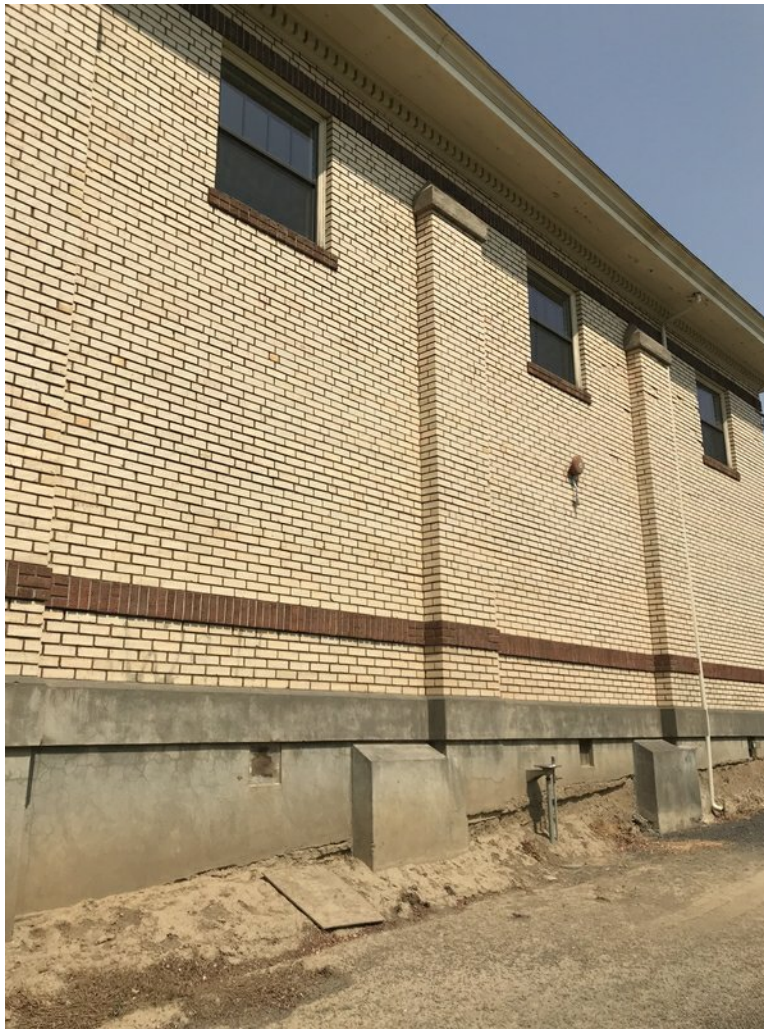
Figure 1-9. South wall of building at the gym. Some foundation wall deterioration is visible at base of wall.

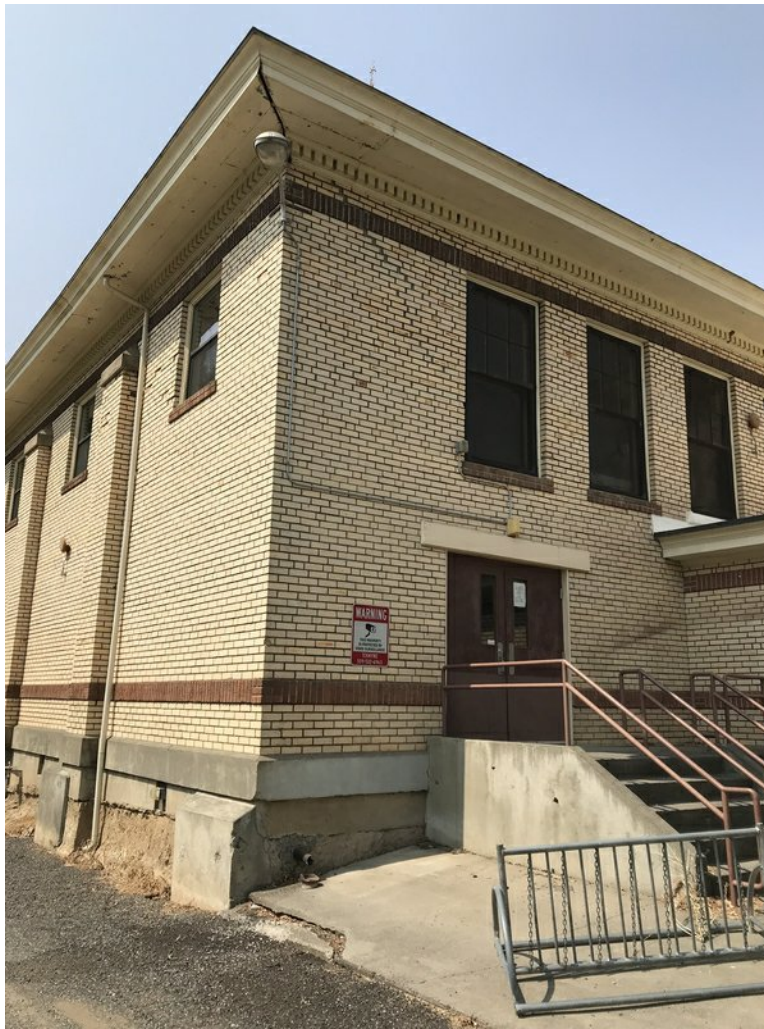
Figure 1-10. Southeast corner of gym. Cracks matching those inside can be seen near corner.
